INSURE

Innovative Sustainable Remediation

REPORT ABOUT PILOT TESTS

5/2019 UHEL

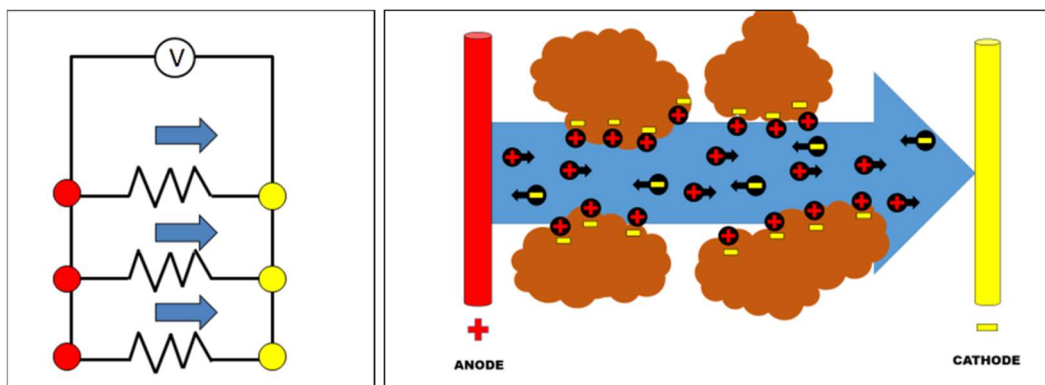
Figure 2.1 a-b. a) The parallel circuit from above, with the movement of the aqueous phase shown in blue arrows. b) cut-view of the mechanism in soil. Soil particles bind ions from the aqueous solution due to their surface charge. The opposite ions remain free in the aqueous media and travel in the electric field according to their charge. Due to its viscosity, water is being dragged along in a horizontal movement and the radius of influence is hence increased.

In biological remediation of sites contaminated with organic compounds, the naturally occurring biological degradation is accelerated by removing the possible bottlenecks of biological activity. The ones most often targeted are lack of oxygen or another electron acceptor, lack of nutrients, of which nitrogen is the most important in terrestrial systems, and lack of moisture when working in the non-water saturated zone. In these cases nutrient amended water is injected into the contaminated zone via ground water tubes. With horizontal tubes the problem may be that the radius of influence is rather limited, and the nutrients end up in ground or surface water instead of the contaminated zone itself. Electro-osmosis can then be introduced to increase the horizontal vector of the injected water. The principle is explained in Figure 2.1.

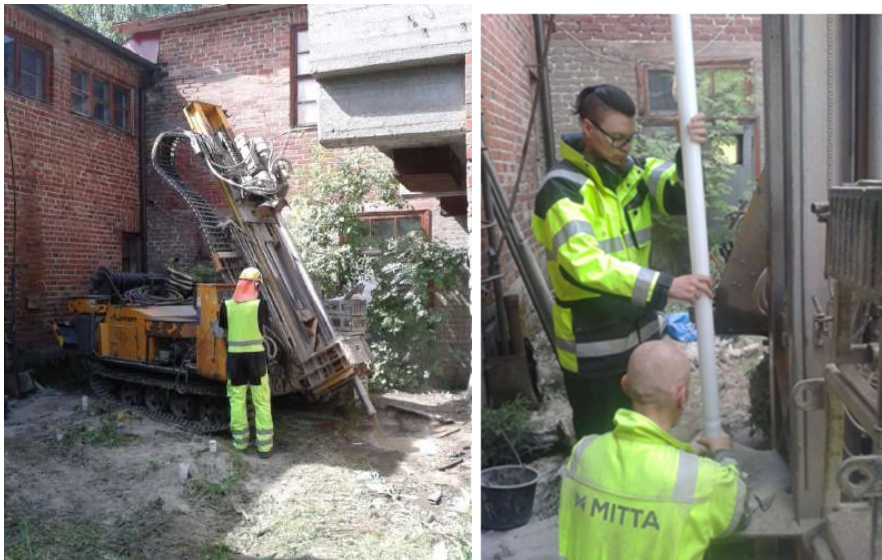
Figure 2.3 a-b. Drilling (a) and installation of perforated tubes (b) at site Nastola in June 2016.

In June 2016, the site was prepared for the *in situ* treatment. In total six drillings were performed to depth 12 m, to enable the installation of two rows of electrodes in perforated plastic tubes (Figure 2.3). The cathode side was thoroughly sampled: samples from depths at which 2/3 of the samples had a strong diesel odor were analyzed for oil hydrocarbon content, resulting in samples from depths 7 to 11 m being analyzed. The treated zone was 10 m x 3 m x 3.5 m and approximately 100 m³ in volume and 130 t in mass.

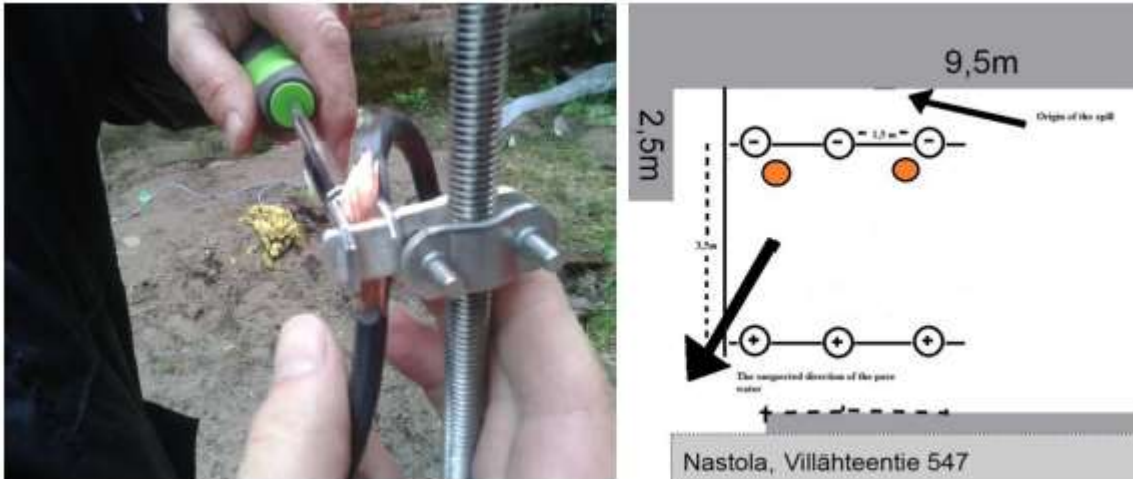
Figure 2.4 a-b. Installation of the electrodes (a). Technical drawing of the area from above (b) Original sampling performed from cathode wells (-), control sampling locations marked by orange spots. The black arrows indicate the origin of the spill (above the cathode row) and the suspected direction of the ground water (to bottom-left)

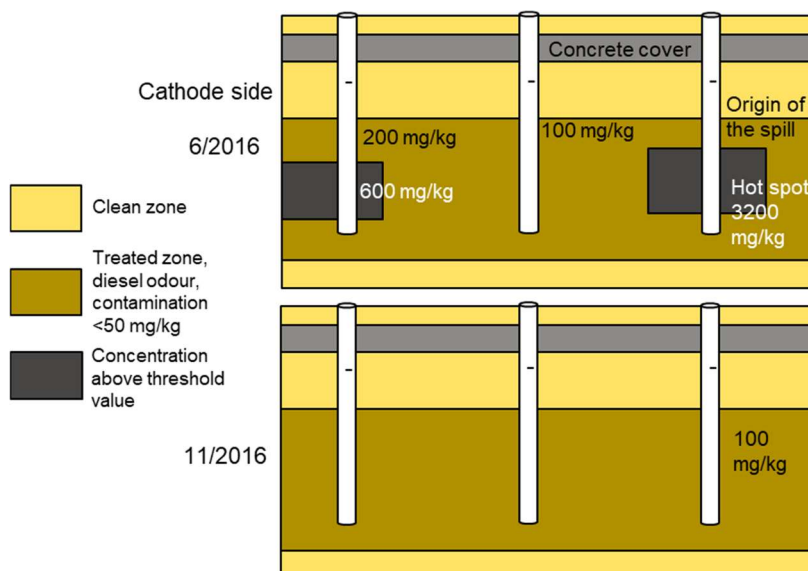
Figure 2.6. A cross-section portrait of the cathode (-) side before and after treatment.

The concentrations in the soil prior to the treatment were mostly under the detection limit even when a strong odor was observed. Two of the 15 samples had concentrations exceeding the threshold value for C10-C40 oil hydrocarbons (300 mg/kg) and the lower guideline value for C10-C21 distillates (300 mg/kg) with an obvious hotspot of 3200 mg/kg dw in 7-8 m depth, near the origin of the spill. After the treatment, three samples with concentrations over the quantification level (LOQ) had average concentration of 100 mg/kg dw and no hot spots with higher overall concentrations were located. The situations before and after 4.5 months of active treatment are shown in Figure 2.6.

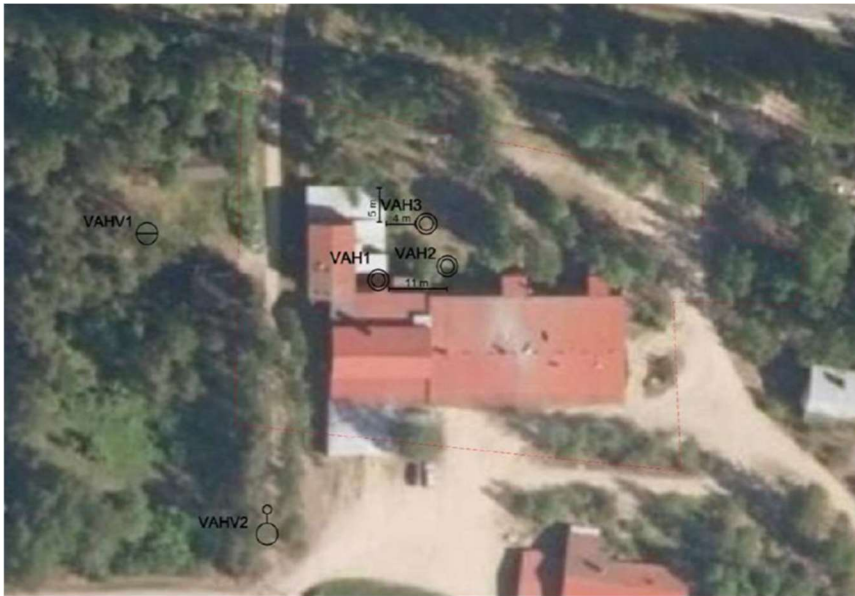
Figure 2.7. The site investigations done by consultant Vahanen Oy with the sampling spots marked.

An independent party, consultant Vahanen Oy, performed the final investigations of the area in April 2017. The soil was sampled in three drillings VAH1-VAH3, with VAL 1 within, and the other two southeast from the treatment zone (Figure 2.7). An organoleptic survey of approximately 1 m length soil columns from depths 8-14 m was performed prior to the standard analysis. Groundwater was investigated from two groundwater wells: VAH 1 to the west from the premises and VAH 2 south from the treated zone. No traces of oil hydrocarbons were found on the site at concentrations above or near the threshold value, and it was concluded that no further actions would be required, neither on the study site nor on the larger area suspected to have been impacted by the spill.

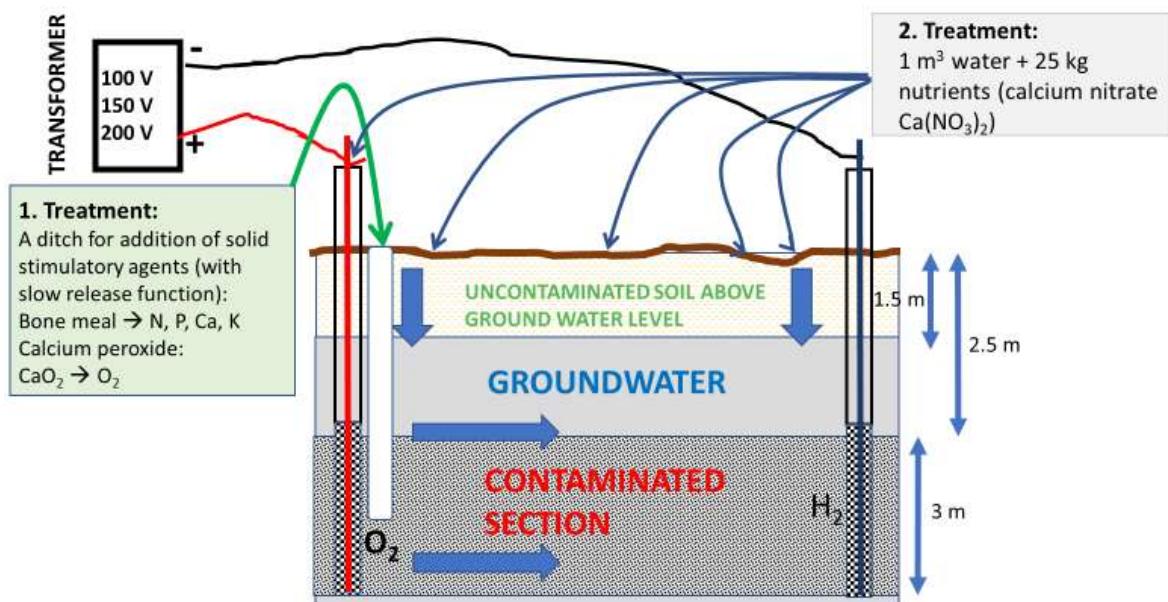
Figure 2.9. A schematic representation of the situation and treatments at Stenavadet. Later obtained data indicated that the water level was fluctuating during the treatment period.

The anode (+) electric cord was attached to the row of electrodes further from the lakeshore, and the cathode (-) cord to the row closer to the lakeshore (Figure 2.9). This arrangement was based on the assumption that the main direction of groundwater flow would be towards the lake. The voltage was turned to the smallest 100V position. The current was measured separately for each of the electrodes.

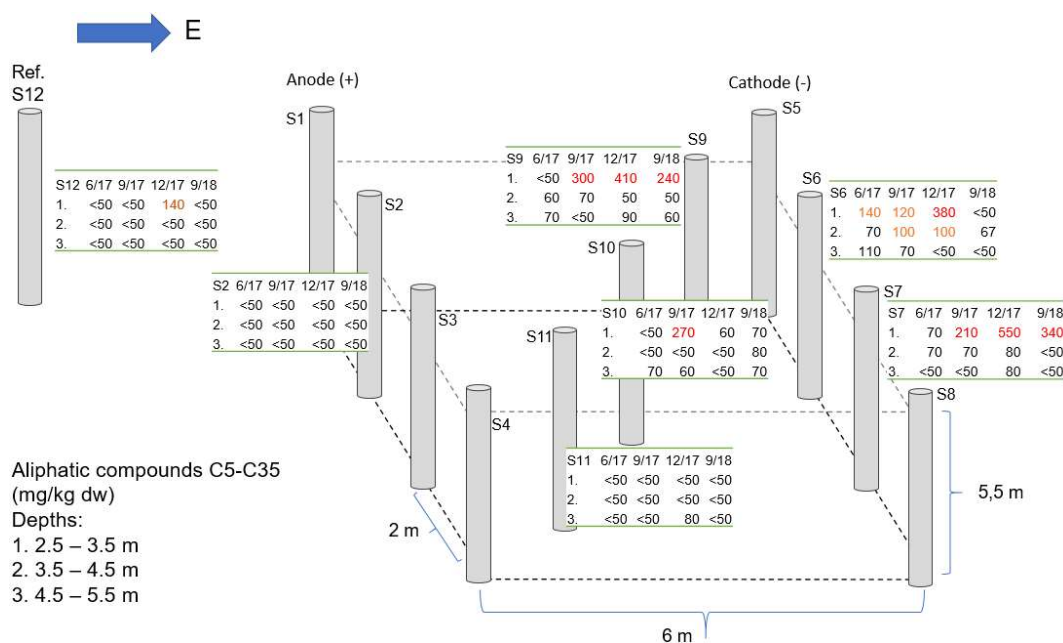
Figure 2.10. Concentration of aliphatic hydrocarbons (C5-C35) in the soil at different depths and sampling dates. Concentrations above 100 mg/kg shown in red.

By the time of the sampling in December 2017, the concentrations of aliphatic compounds had not decreased (Figure 2.10). Instead, a possible trend was observed of the oil being mobilized by the slightly elevated temperature and electro-osmotically enhanced groundwater movement. This was supported by the fact that the oil hydrocarbon levels had risen in the top samples and also into the direction of the shore. Mobilized oil would float up to the surface of the groundwater and form a non-aqueous phase liquid (NAPL). This NAPL would then be slowly transported towards the cathodes.

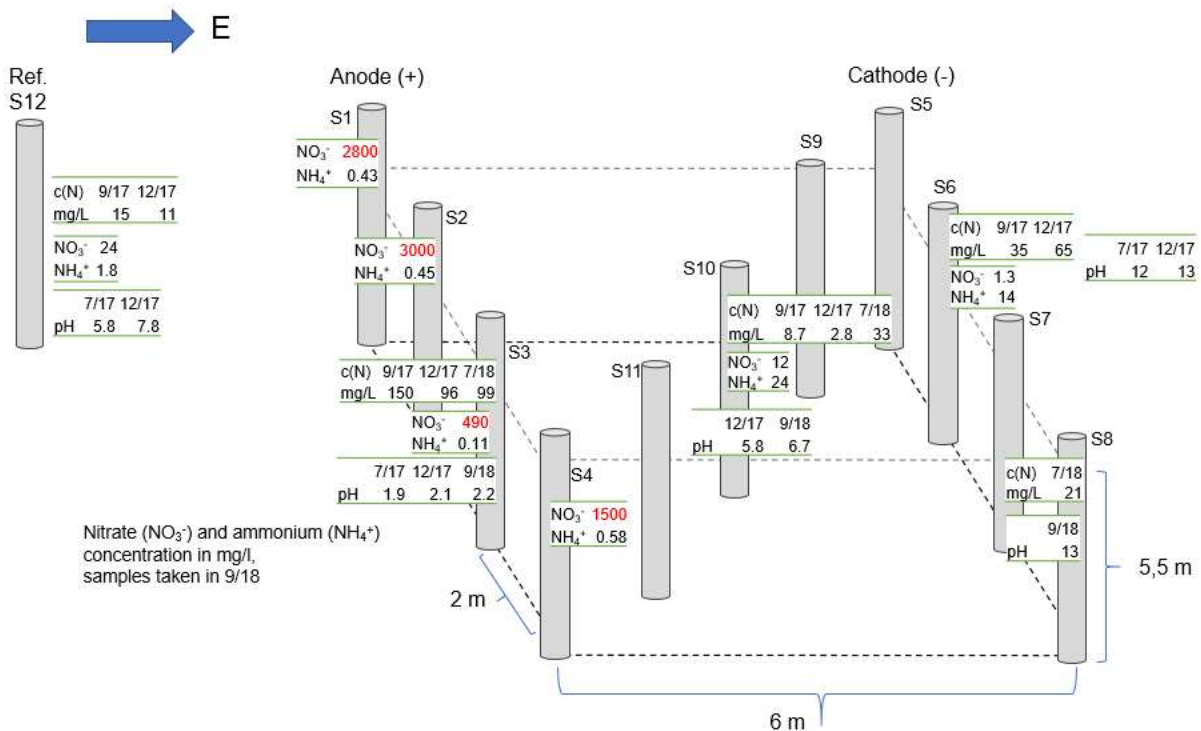
Figure 2.11. Concentrations of total nitrogen (N), nitrate (NO₃⁻) and ammonium (NH₄⁺) and the groundwater pH.

Changes in pH were also monitored. It was found that during the remediation pH in groundwater was very low at the anode site (ca 2), whereas in the middle of the area it was only slightly acidic or near neutral (5.8-6.7) (Figure 2.11). At the cathode site, pH was highly alkaline (near 13). However, pH in soil samples was near neutral and did not vary clearly, indicating a high buffering capacity of the soil.

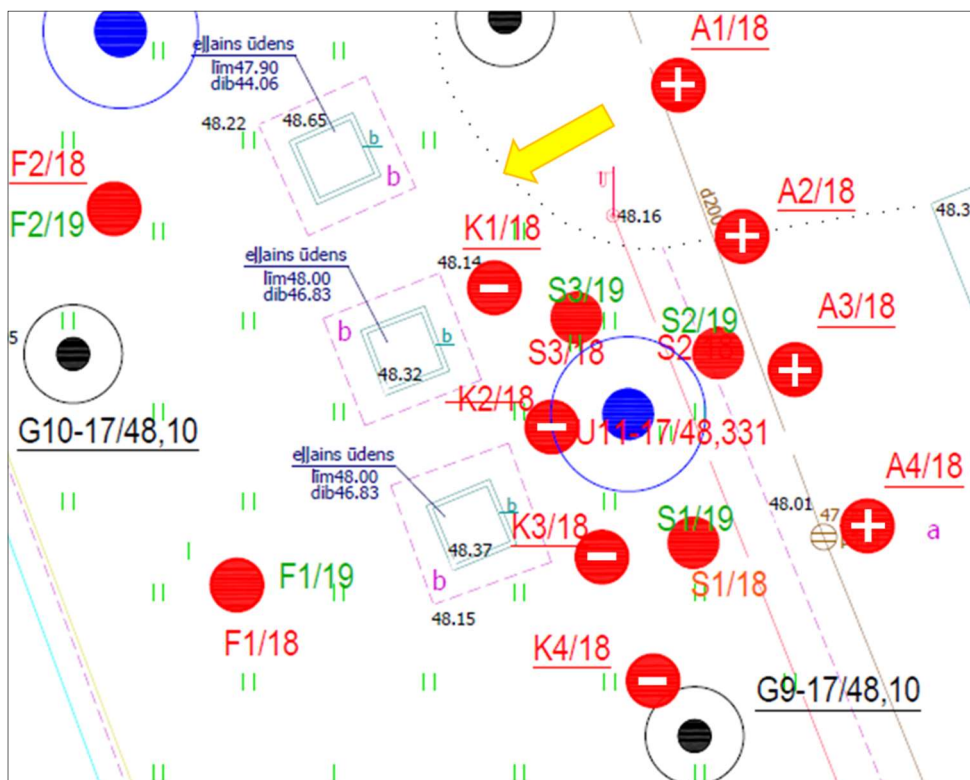
Figure 2.13. The treatment site, showing the anode row marked with (+) and the cathode row with (-). The yellow arrow marks the suspected movement of fluids. The two control drillings outside the treatment area are marked as F1 and F2. The number after the slash character indicates the sampling year. The sampling points inside the treatment area are marked as S1-S3.

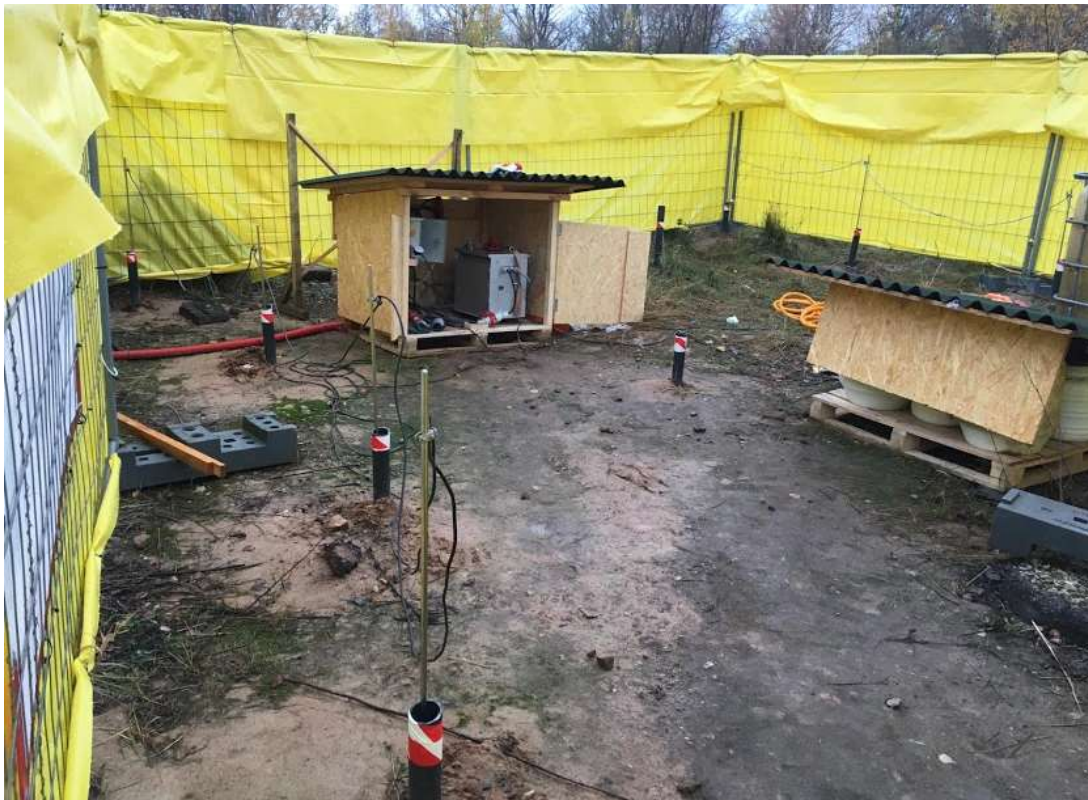
Figure 2.14. Finished site installations. The anode side on the left, the cathode side on the upper right near the fence. Tubes in between mark monitoring sampling spots.

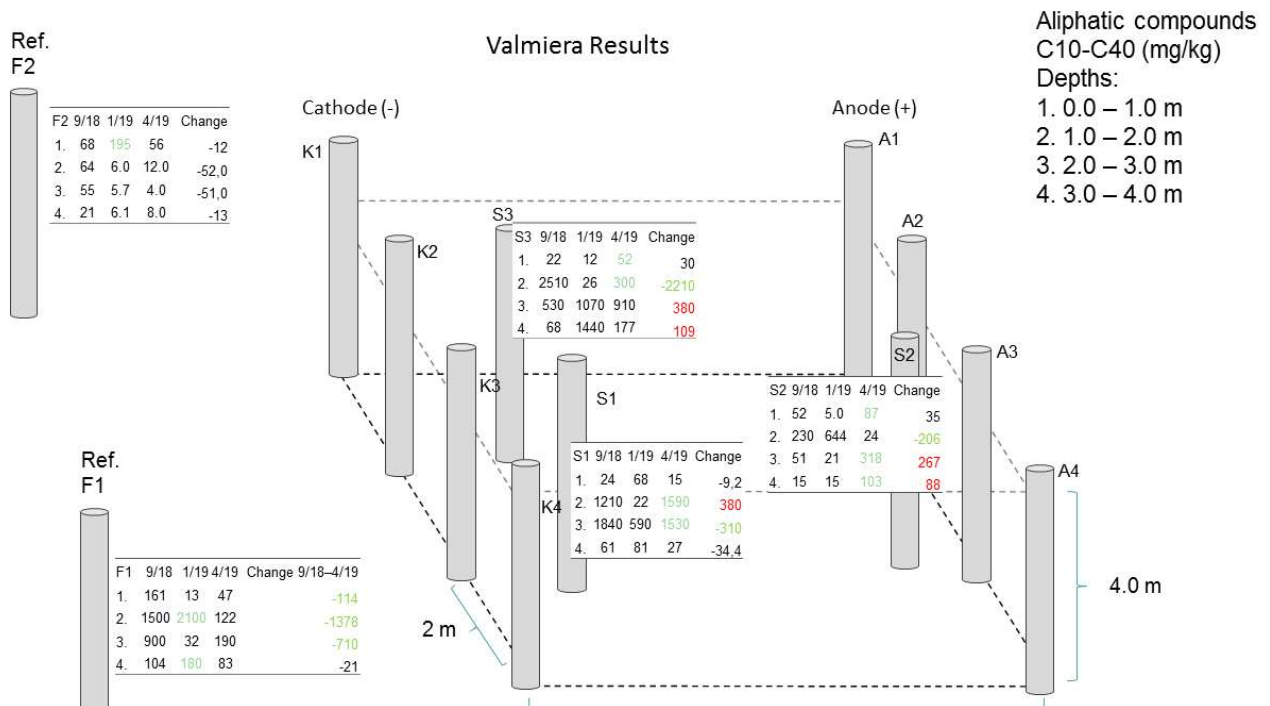
Figure 2.15. Oil hydrocarbon results from soil, from investigations in 9/18, 1/19 and 4/19.

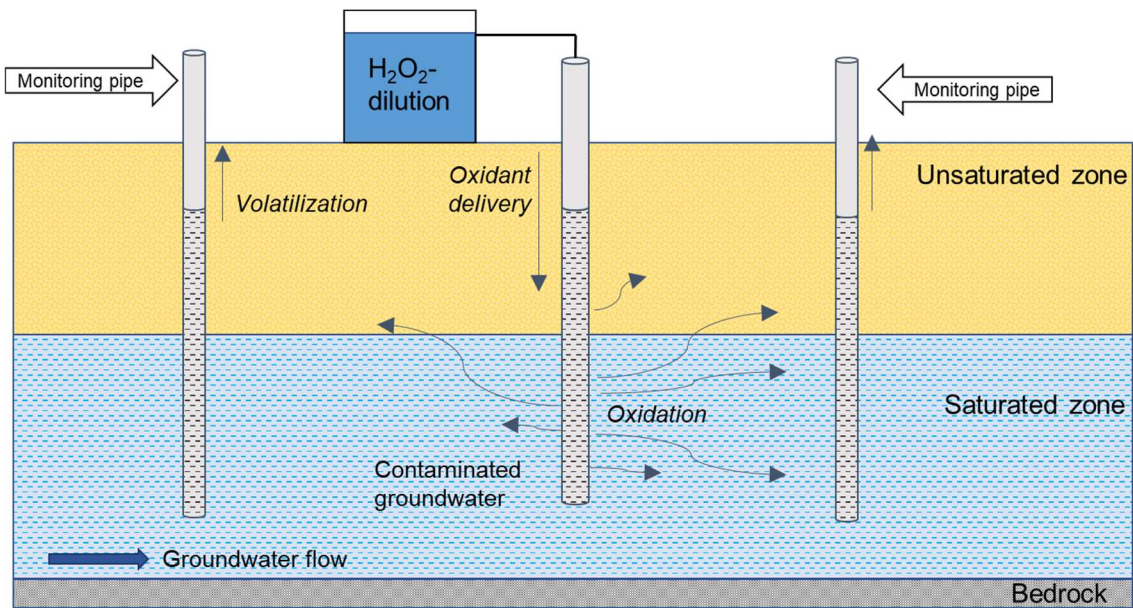
Figure 3.2. Principle of peroxide sparging in the saturated zone

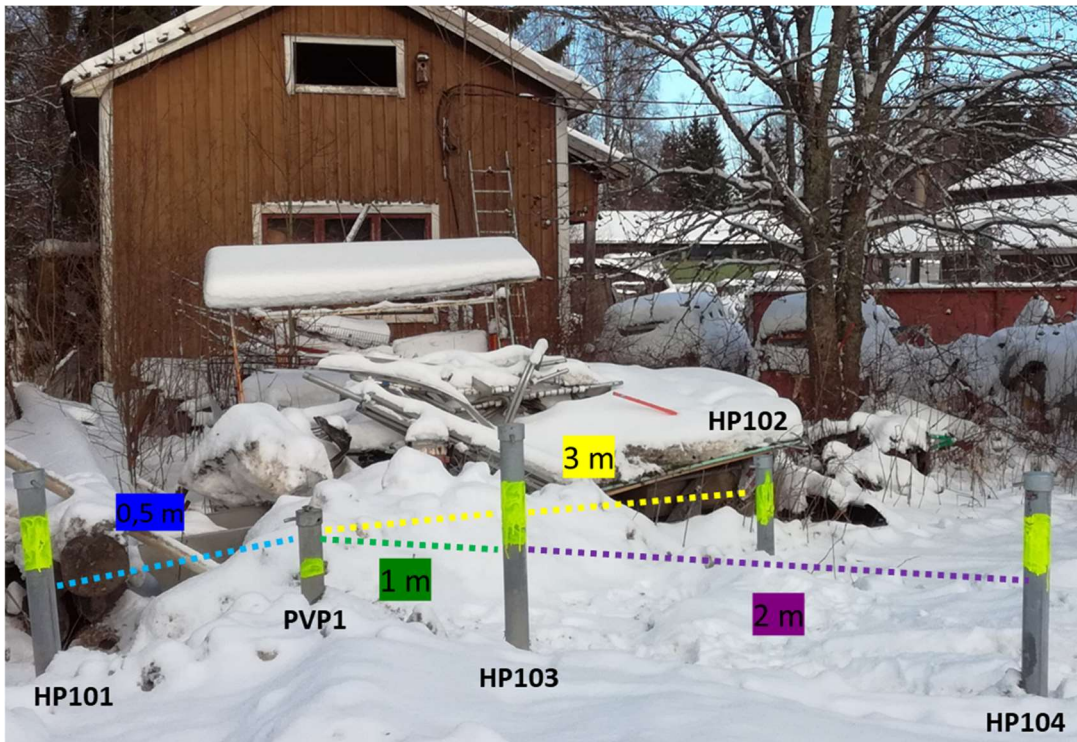
Figure 3.3. The original treatment area showing the distances between each groundwater pipes.

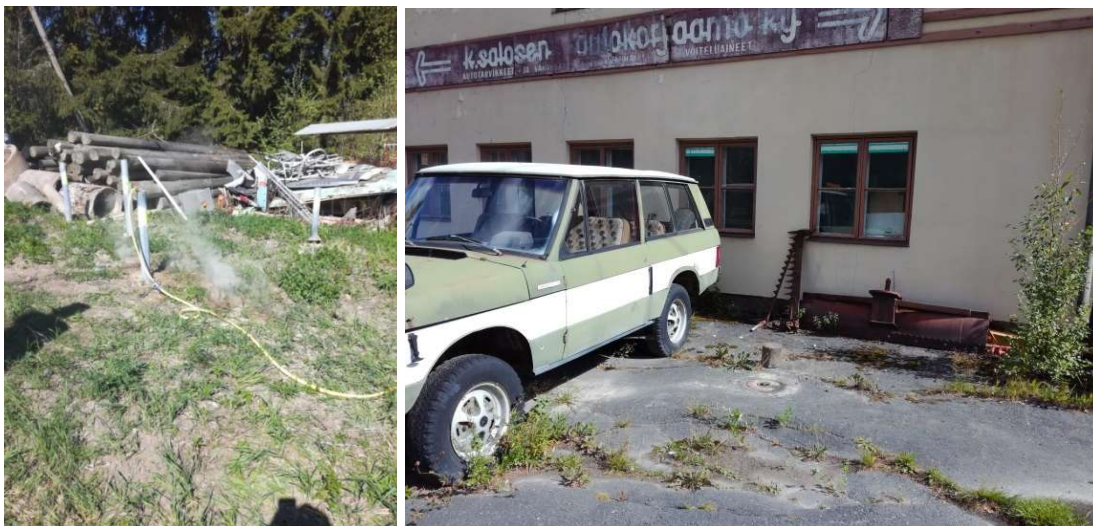
Figure 3.4 a-b. PVP1 area (a) and PVP3 area (b) during the second period of the experiment.

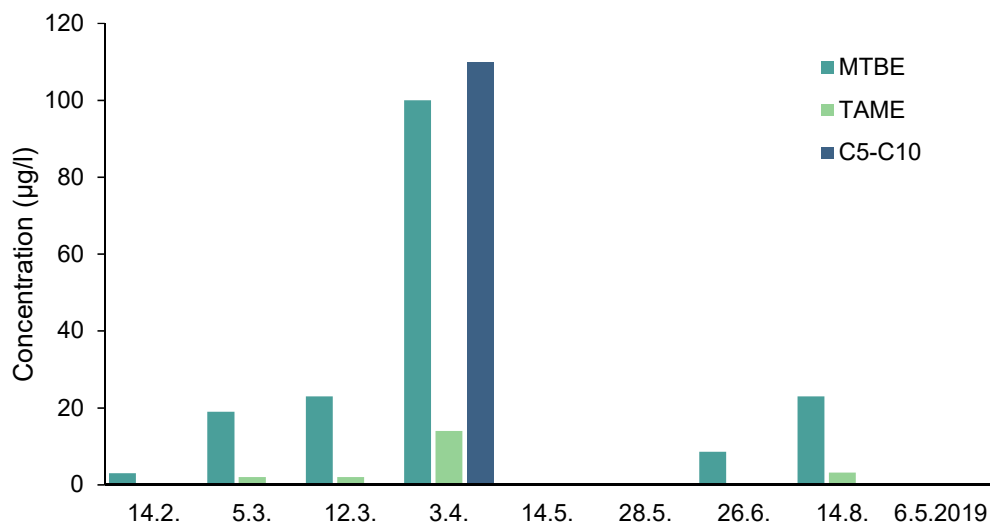
Figure 3.5. The concentrations of MTBE, TAME and C5-C10 ($\mu\text{g/l}$) in monitoring pipe HP104.

One month after the second stage of remediation, it was found that the concentrations of MTBE in these tubes had increased compared to the initial concentrations. In addition, TAME was detected in small concentrations in both tubes. The concentrations of VOCs analyzed from tube HP102 were still below the LOQ. The remaining two tubes were not sampled due to the previously clean samples. The site was revisited in May 2019 to see whether the concentrations had rebounded. None of the targeted VOCs were detected from samples taken from the pipes HP104 and PVP1, indicating that the original treatment area was still clean.

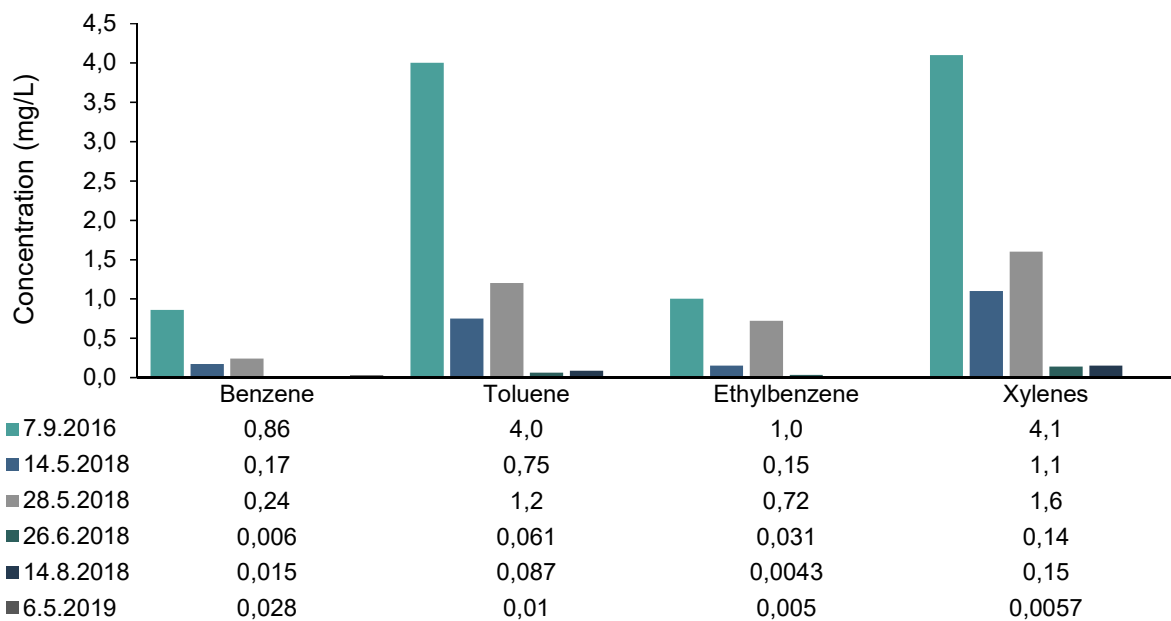
Figure 3.6. BTEX concentrations in groundwater before (2016) and after H₂O₂ injections.

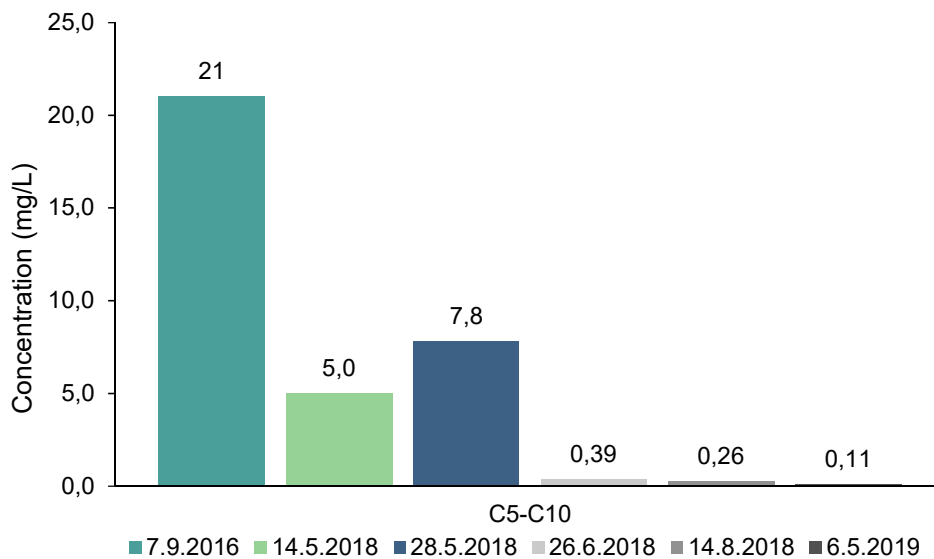
Figure 3.7. Gasoline concentrations in groundwater before (2016) and after H₂O₂ injections.

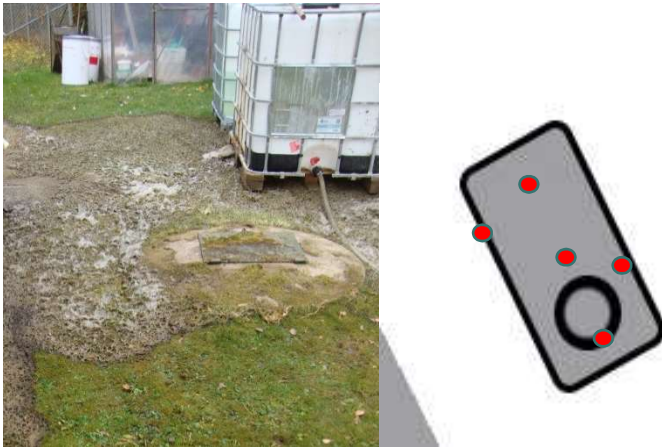
Figure 3.8 a-b. The site after the chemical oxidation treatment (a) and a drawing of the tank with the sampling spots in red (b). Only the results from the three spots on the bottom axis have been used for the surveys, because the other two are higher up the ceiling from where samples could not be withdrawn during all stages of the treatment and also since these concentrations were found to be negligible by comparison.

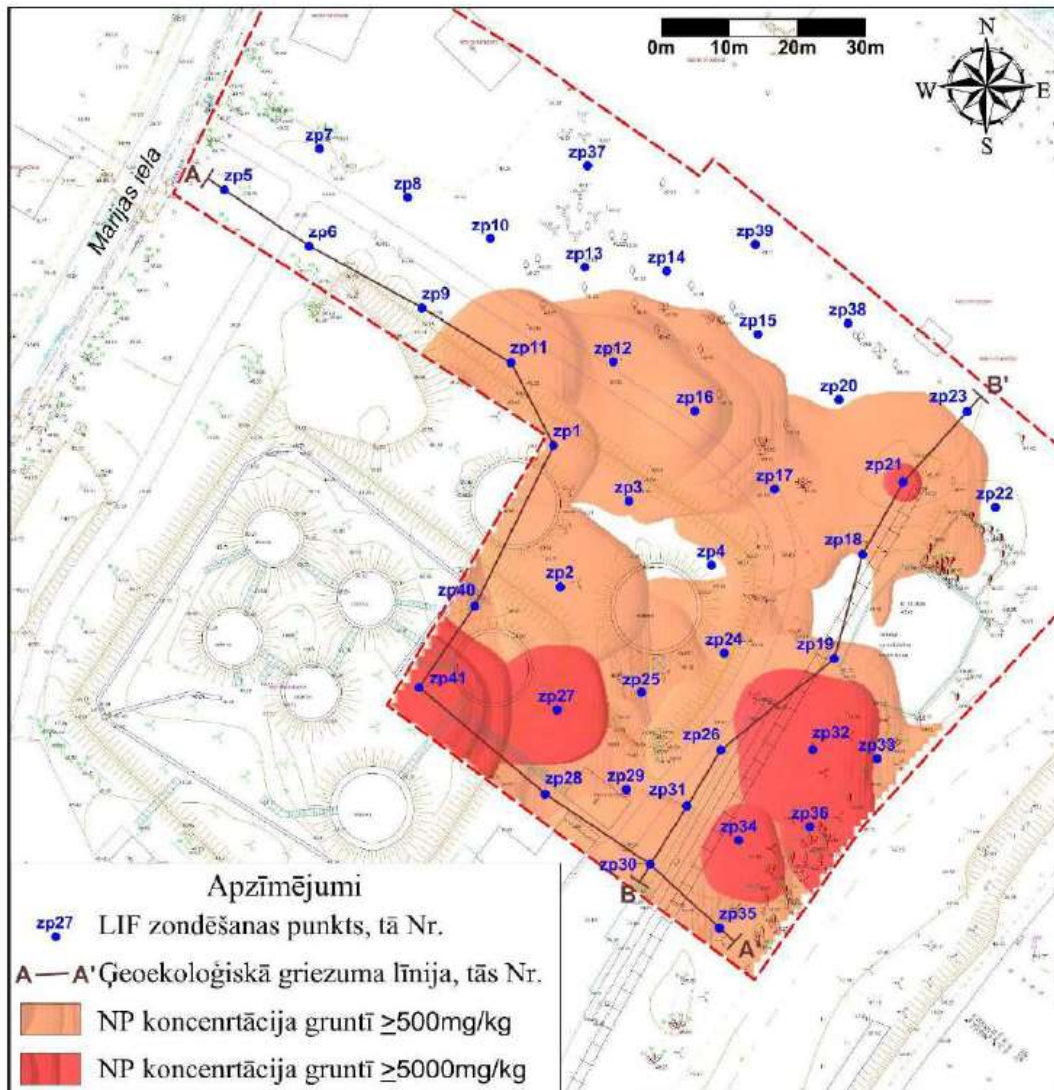
Figure 6.2. A map from the site, showing the most polluted areas. An orange-red color indicate areas with oil hydrocarbon content ≥ 500 mg/kg and red areas ≥ 5000 mg/kg.
