INSURE

Innovative Sustainable Remediation

SITE PROGRESS REPORT 3 (1/2019) UHEL

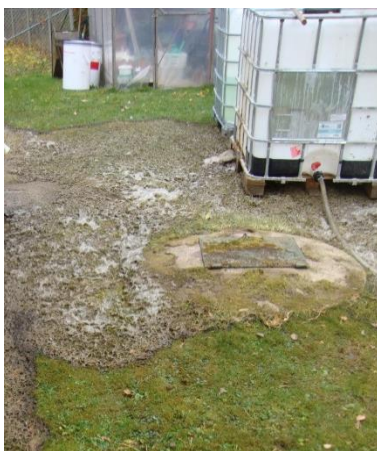
Fig 1.1. The site after the chemical oxidation treatment

Preliminary studies and activities on the site were performed during project Tankki in 2013-2014 by superintendent Ramboll Finland Oy, and the contractor responsible for treatments, Nordic Envicon Oy. The study site is located on a residential area on the premises of a single household (Fig 1.1.). The leaking was due to a hole or holes in the private heating oil tank dug in the ground, approximately 1 m from the north corner of the house, left intact, and suggested to remain so by the landowner. The contamination on the area is heterogeneously distributed with concentrations from 2,5-3 meters, near the bottom of the tank, varying between <50 mg - 3300 mg/kg. The soil is clayey and highly impermeable, Because of this, and because it was suspected that the soil under the tank was coarser and had high concentrations, the sampling and water injections were decided to be performed through small holes in the tank itself. For this, five holes (4 cm \varnothing) were drilled (Fig 1.2.). Higher concentrations were indeed found in the preliminary sampling. Because of the soil mobilization, the original sampling holes could be used repeatedly for subsequent samplings.

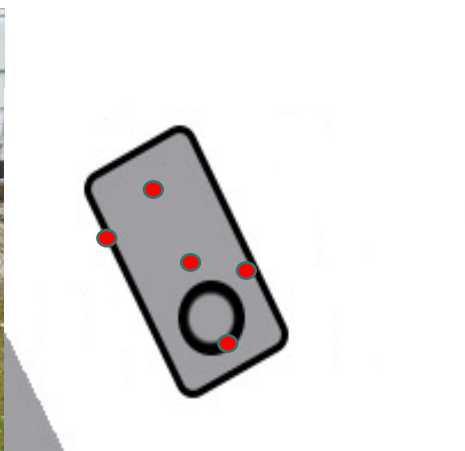
Fig 1.2. Drawing of the tank with the sampling spots in red, only the results from the three spots on the bottom axis have been used for the surveys since the other two are higher up the ceiling where the oil hydrocarbon concentrations are negligible by comparison.

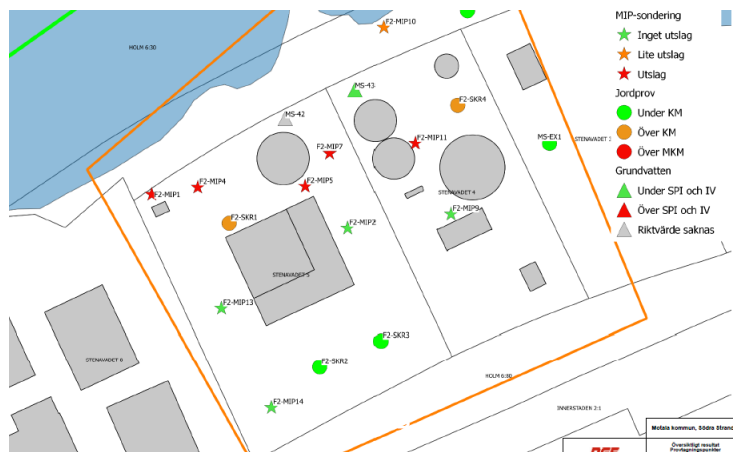
Fig 2.1. The oil hydrocarbon contaminated site Södra stranden.

Sampling, drilling and installations for the UHEL's electro-osmotic biostimulation treatment for the oil hydrocarbon contaminated site (Fig 2.1.) were made by Sweco in June 2017, as explained in detail in the site progress report 2 (1/2018).

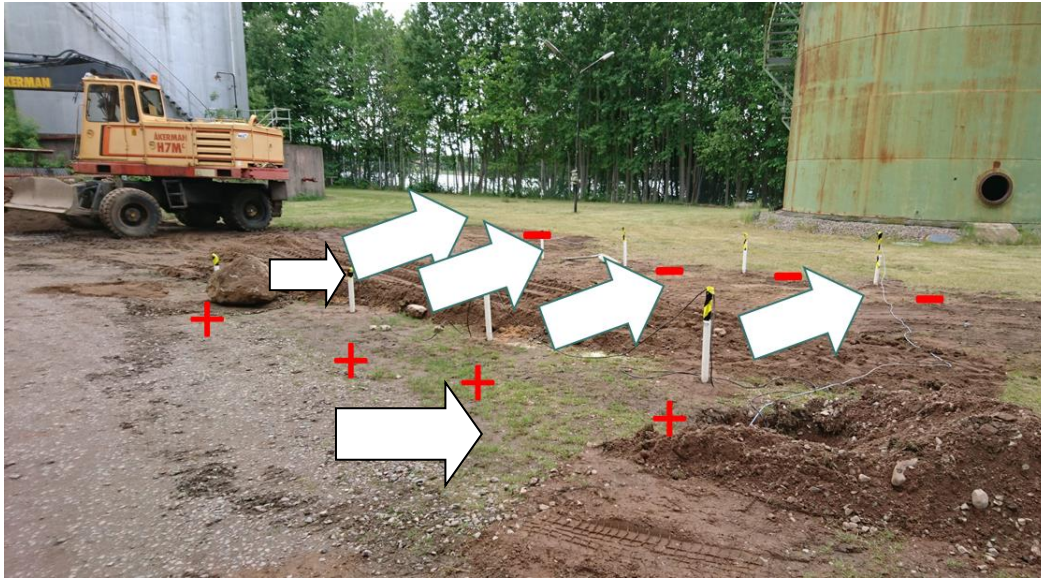
Fig 2.2. The study area with the direction of the electric field: anodes to the left, cathodes to the right. Water flow direction is also from left to right, from anode to cathode.

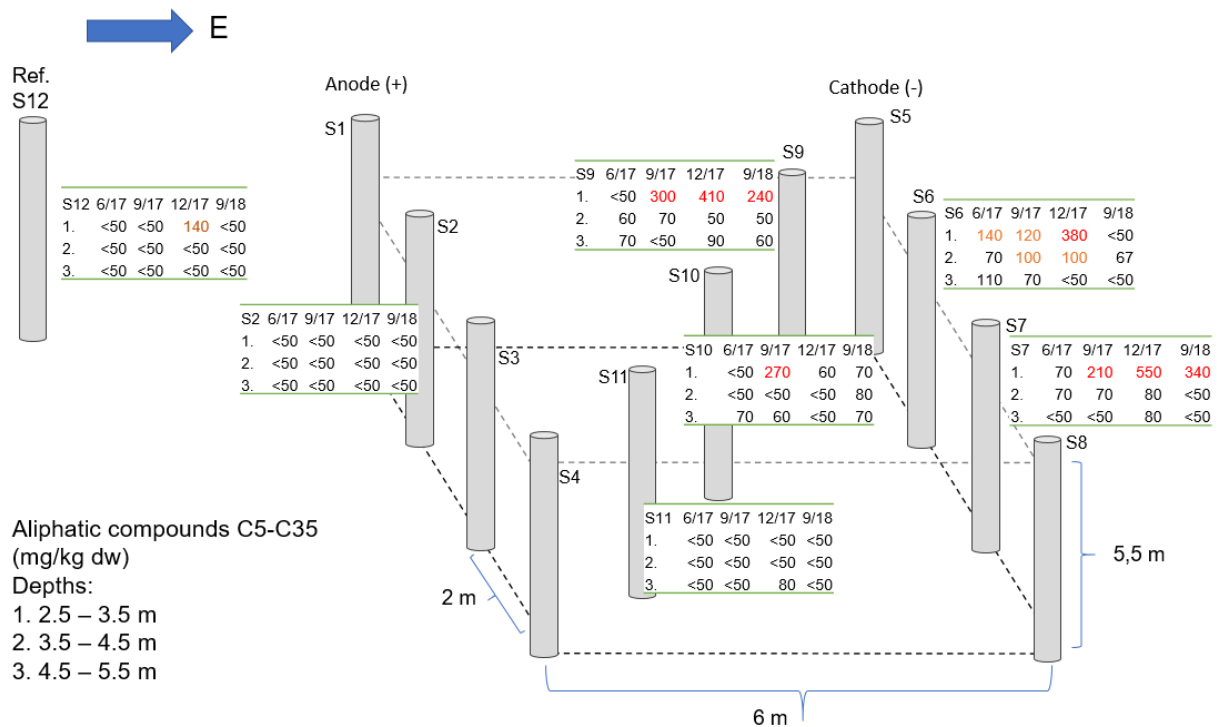
Fig 2.3. Concentration of aliphatic hydrocarbons (C5-C35) in the soil at different depths and sampling dates.

By the time of the sampling in December 2017 the concentrations of aliphatic compounds had not decreased (fig 2.3) as explained in site report 1/2018. In addition to the data in the figure, the temperature and the oxygen concentrations in the ground water were measured. The temperature in the field was slightly elevated compared to the controls. The oxygen in the anode tubes was oversaturated (> 30 mg/L) while in the middle of the field it was 2 mg/L showing that oxygen was actively consumed. As high concentrations of oxygen had been detected only in the anode pores, and since nitrogen had already been detected in sufficient doses also outside the source, it was suspected that oxygen was the primary limiting factor. To increase the degradation, 25 kg package of calcium nitrate with 1000 liters of water were mixed in a Cipax tank and the solution was distributed over the test area in the end of April 2018. Nitrate (NO_3^-) was used because it can function as an alternative electron acceptor replacing oxygen. The addition was done every other week for twelve weeks, six times in total. Site treatment was finished in September 2018.

In the end of experiment the concentration of aliphatic hydrocarbons had decreased. Compared to the highest concentrations detected in December 2017, concentrations had decreased ca 40-70 %. However, the concentrations were still relatively high in two spots (S9 and S7, fig 2.3), indicating that the method was not as efficient as expected. Probably with prolonged treatment time the concentrations would have been even lower.

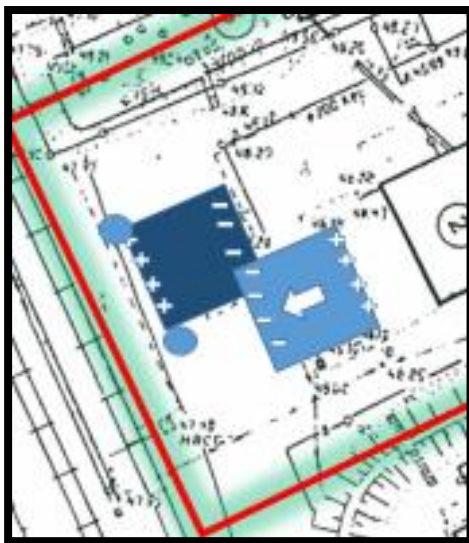
Fig 3.1. The treatment site: the original target area marked in darker blue with the intended electrode rows marked with (+) and (-) symbols. The new chosen site in lighter blue with the suggested anode row marked with (+) and the cathode row with (-). The arrows mark the suspected resulting movement of fluids. The two control drillings outside the treatment area are marked with spots in light blue.

On Wednesday, the positions of the electrode rows were determined and marked. The smaller area pinpointed in the original plan was, and had already been, found unsuitable because of underground tanks that would potentially compromise both the drillings and the treatment. The new study square was set to include the ground water well from where the highest oil hydrocarbon contamination levels had been measured, and otherwise the 6 x 6 m² square was set in the only possible way for it to be accessible for the heavy drilling machinery. The direction of the forming electrical circuit was chosen to direct the injected fluids towards the area suggested to be the most contaminated, that is, the original targeted site around the underground tanks (fig 3.1).

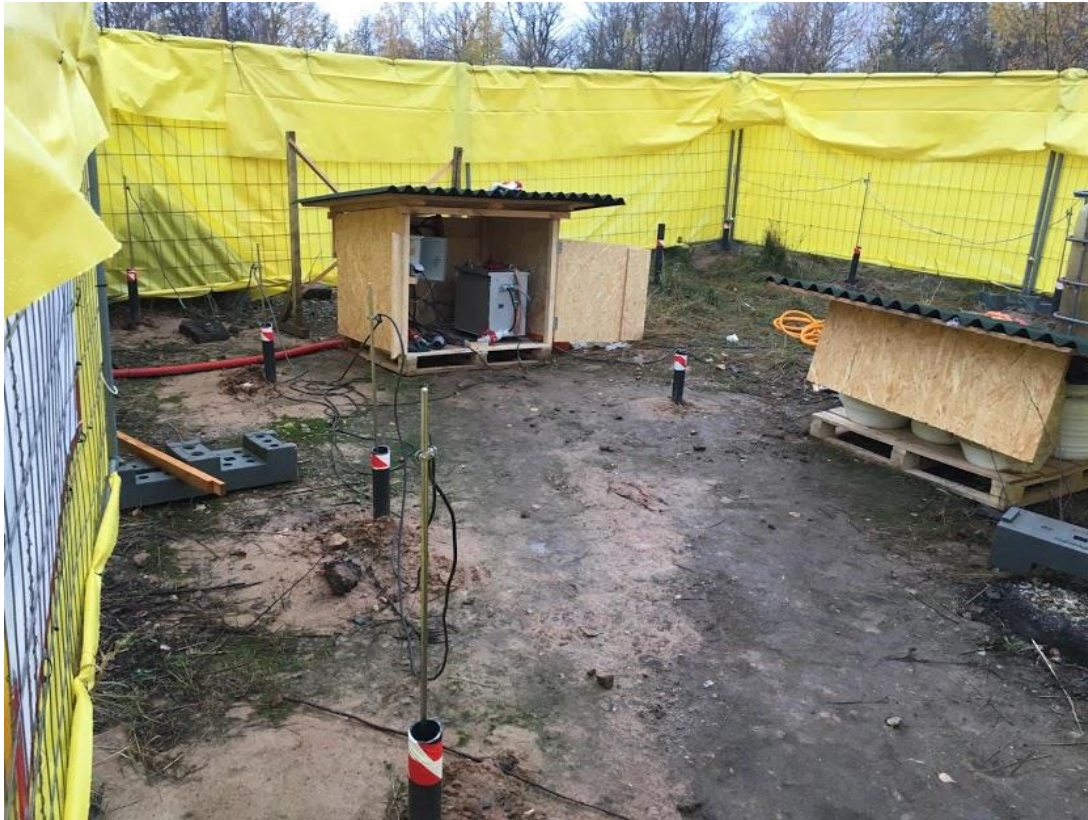
Fig. 3.2. Finished site installations. Anode site on the left, cathode site on the upper right near fence. Tubes in between mark alternative sampling spots.

All installations were completed by the time of the INSURE partner meeting in early October 2018, during which Martin Romantschuk and Harri Talvenmäki visited the site to see everything was running as planned (Fig 3.2)

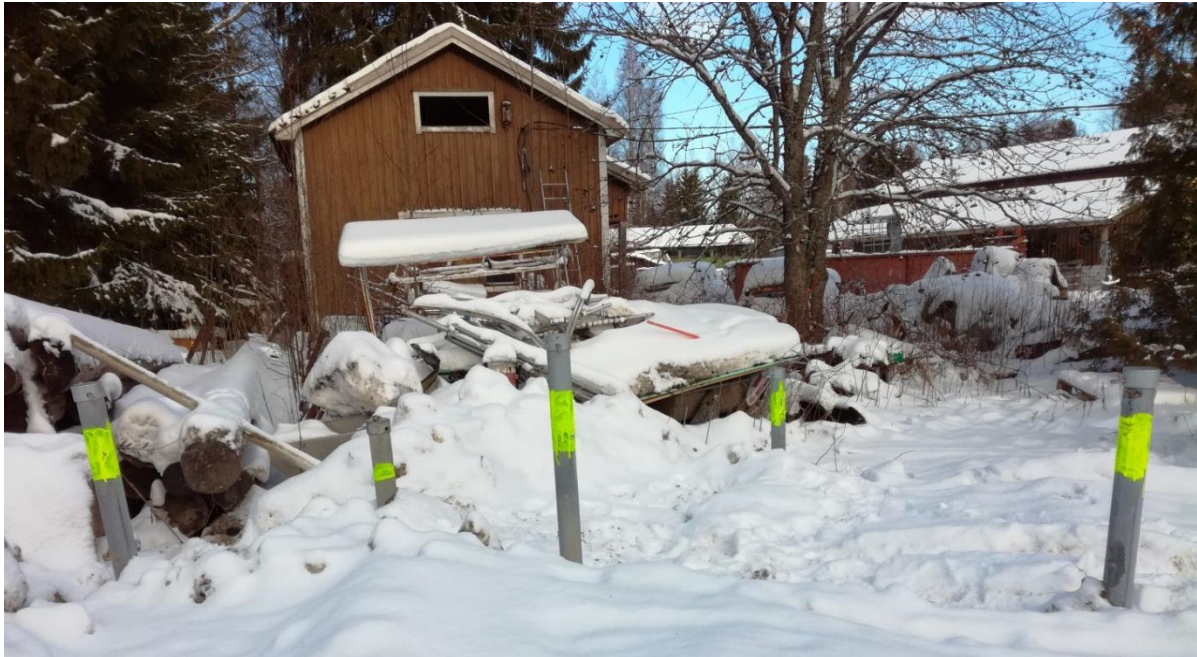
Fig 7.2. The site used for both frozen and molten soil tests, surrounding PVP 1.

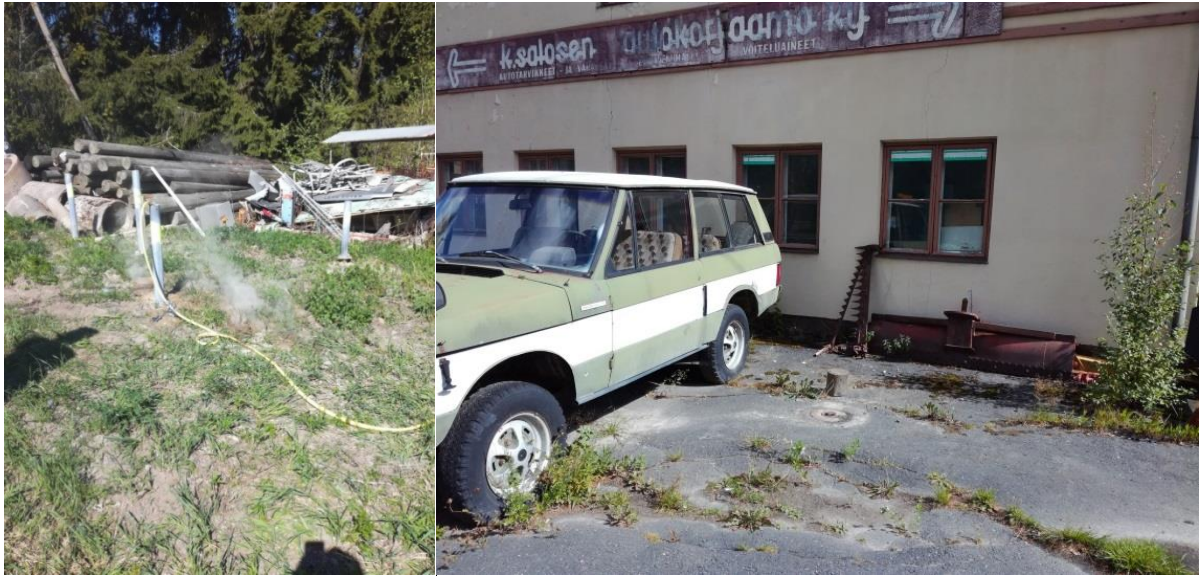
Fig 7.3 a-b. PVP 1 area (a) and PVP 3 area during the 2nd period of the experiment

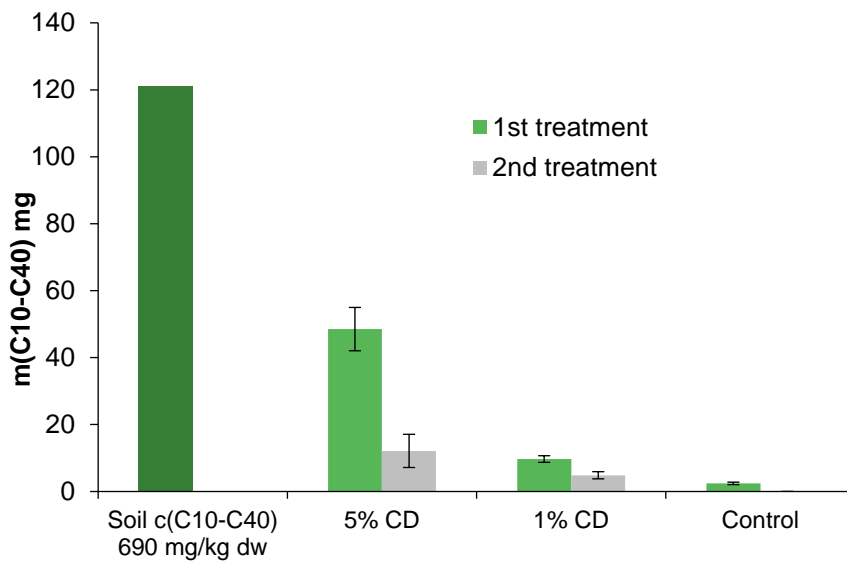
Fig 8.1. Amount of oil (mg) dissolved in water. On the left is shown the amount of oil in homogenized soil (multiplied with soil dry weight 0.18 kg)

Based on the results, the treatment affects the hydrocarbon concentrations in water and the mean values of the different treatments differ at both times for all measured oil hydrocarbon groups (C10-C40, C10-C21 and C21-C40) (fig 8.1). The removal efficiency remained high, especially with the C16-C21 aromatic compounds. With C10-C12 aliphatic compounds, the final removal rate (48%) was achieved during the first shakings. Also, it was found that the efficiency was dependent on the CD concentration; by using 1% CD final but weaker result was achieved in the same time than by using 5 % CD. The same phenomenon appears to be less pronounced with other fractions, i.e. on the second time, the original efficiency decreased on average by about one third, regardless of the CD concentration. The results suggest that the additive could be used either for more effective biological treatment or for soil flushing. The dose would need to be selected on the basis on which of the two methods is more desirable: with higher dose the removal rate is higher, but in biological treatment only small amount of oil hydrocarbons should be mobilized at a time so that they are biodegraded in sufficient timeframe to avoid the overt risk of mobilization.
