INSURE

Innovative Sustainable Remediation

SITE PROGRESS REPORT 2 (1/2018) UHEL

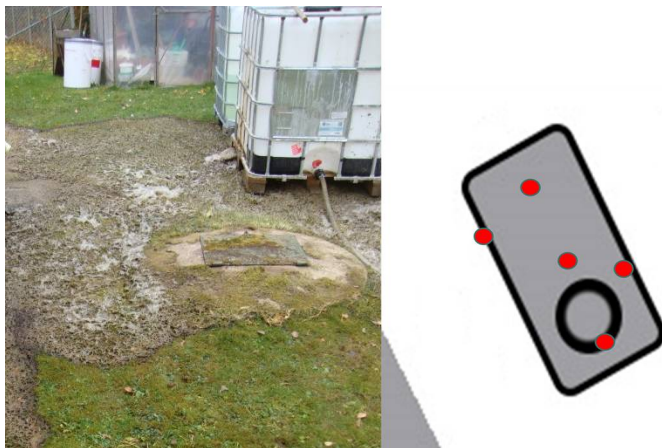
Fig 1.1. The site after the chemical oxidation treatment

Preliminary studies and activities on the site were performed during project Tankki in 2013-2014 by superintendent Ramboll Finland Oy, and the contractor responsible for treatments, Nordic Envicon Oy. The study site is located on a residential area on the premises of a single household (Fig 1.1.). The leaking was due to a hole or holes in the private heating oil tank dug in the ground, approximately 1 m from the north corner of the house, left intact, and suggested to remain so by the landowner. The removal is ruled out because of the vulnerable location near the house and connected sub-surface structures. The contamination on the area is heterogeneously distributed with concentrations from 2,5-3 meters, near the bottom of the tank, varying between <50 mg-3300 mg /kg. The soil is clayey and highly impermeable, Because of this, and because it was suspected that the soil under the tank was coarser and had high concentrations, the sampling and water injections were decided to be performed through small holes in the tank itself. For this five holes (4 cm \varnothing) were drilled (Fig 1.2.). Higher concentrations were indeed found in the preliminary sampling. Because of the soil mobilization the original sampling holes could be used repeatedly for subsequent samplings.

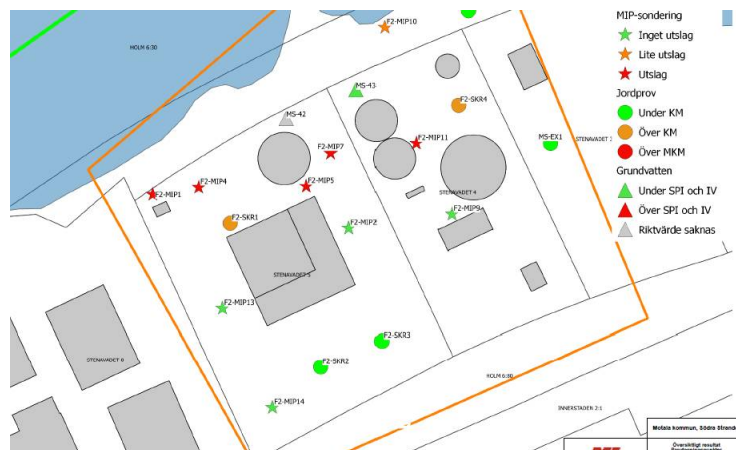
Fig 2.1. The oil hydrocarbon contaminated site södra stranden

Sampling, drilling and installations for the UHEL's biostimulation treatment for the oil hydrocarbon contaminated site (Fig 2.1.) were made by Sweco in June 2017, commissioned by Hanna Wåhlen from SGU who was also present. Therese Hjälms and Therese Erlandsson represented the municipality of Motala and Martin Romantschuk represented the University of Helsinki. The electrician present was Larsson from Veteranpoolen. Anders Andersson, the owner, was present most of the time, and he did the digging.

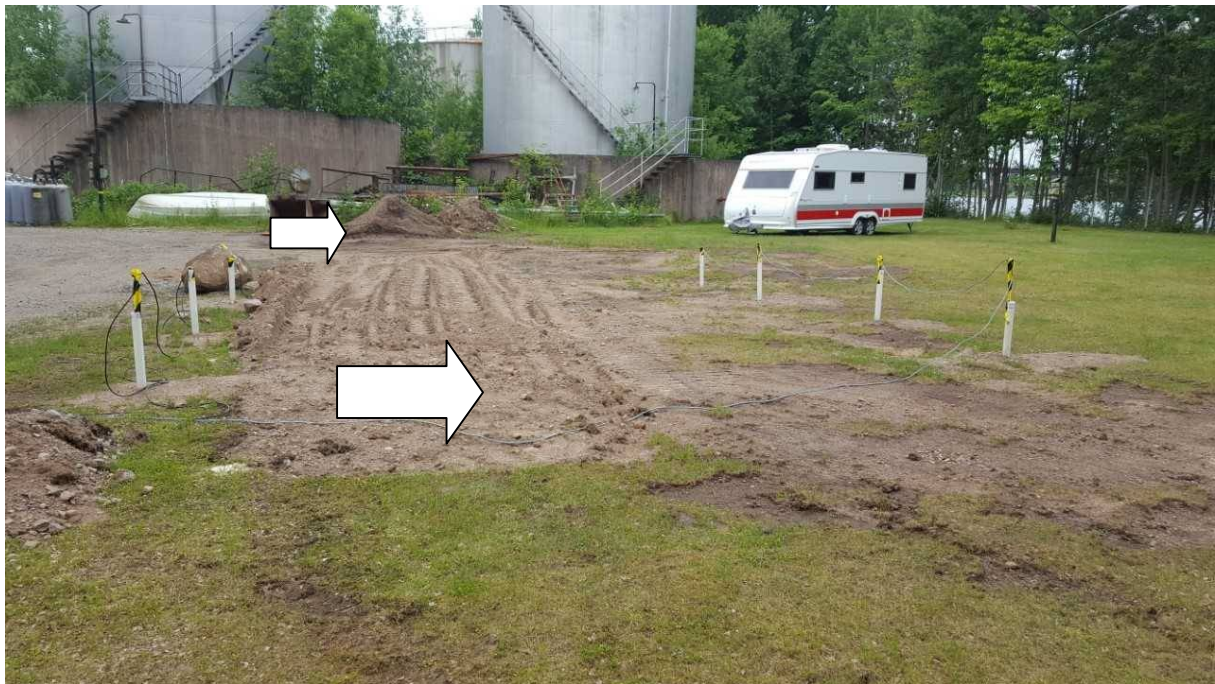
Fig 2.2. the study area with the direction of the electric field shown in white arrows

The anode (+) electric cord was attached to the row of electrodes further from the lake shore, and the cathode (-) cord was attached to the row closer to the lake shore (Fig 2.2.). This arrangement was based on the assumption that the main direction of ground water flow would be towards the lake.

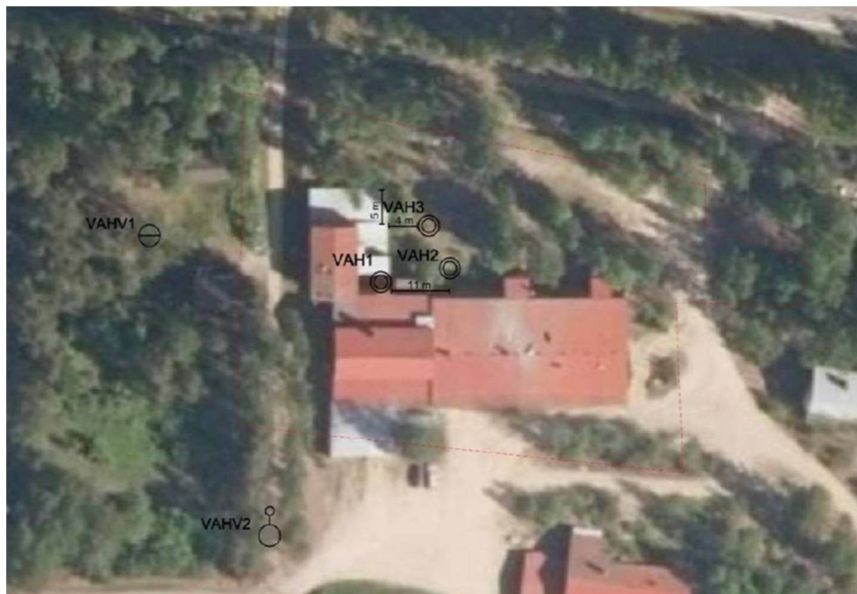
Fig 5.3. The site investigations done by consultant Vahanen Oy with the sampling spots marked

The final investigations on the area were performed by an independent party, consultant Vahanen Oy, who could apply both the investigations and the risk assessment for a price under the tender threshold, since the personnel were involved with the original site investigations around project Tankki in 2013, then done by Ramboll Oy, who had a thorough knowledge of the case. The investigations were performed as three drillings VAH1-VAH3, with VAL 1 within, and the other two southeast from the treatment zone (Fig 5.3). Organoleptic survey of approximately 1m length soil columns from depths 8-14 m was performed prior to standard analysis. Groundwater was investigated from two groundwater wells: VAH 1 to west from the premises and VAH 2 south from the treated zone. No traces of oil hydrocarbons were found on the site on concentrations above or near the threshold value, and it was concluded that no further actions are needed, either on the study site or the zone suspected to have been impacted by the spill.

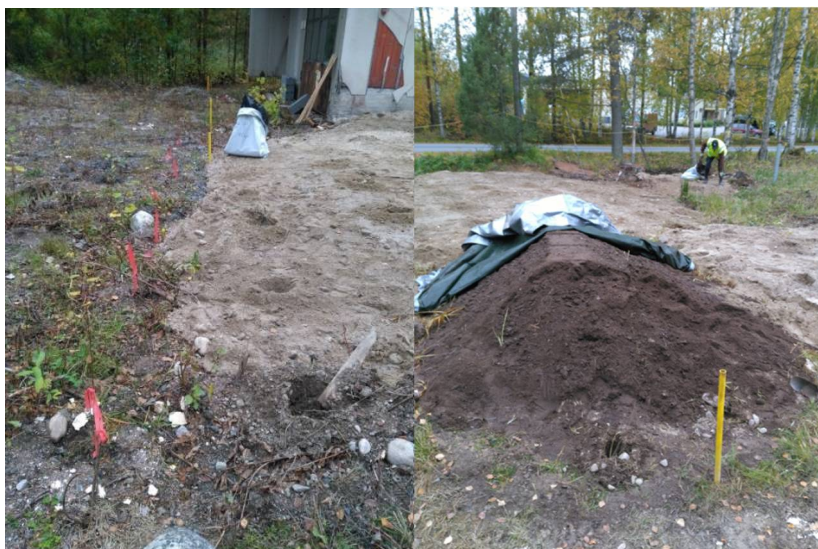
Fig 6.1. Oil and Hb-contaminated hot spots removed by digging before starting the planting

In 2017 two spots on the site were still found to have very high concentrations of hydrocarbons and heavy metals respectively, and they had to be removed by excavation before starting of the planting.

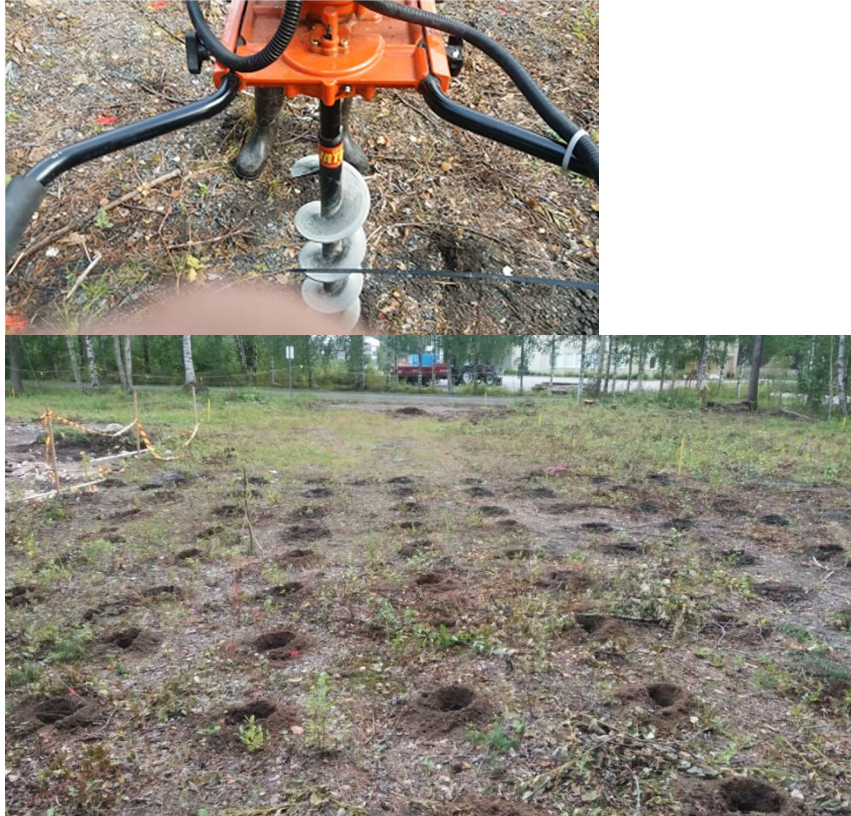
Fig. 6.2. a-b. Drilling holes for planting at the Kiertotie 18 industrial site in Virrat

The soil at the Kiertotie 18 site is very stony and compacted, and drillings had to be done prior to the planting of hybrid aspen plants in 2017.

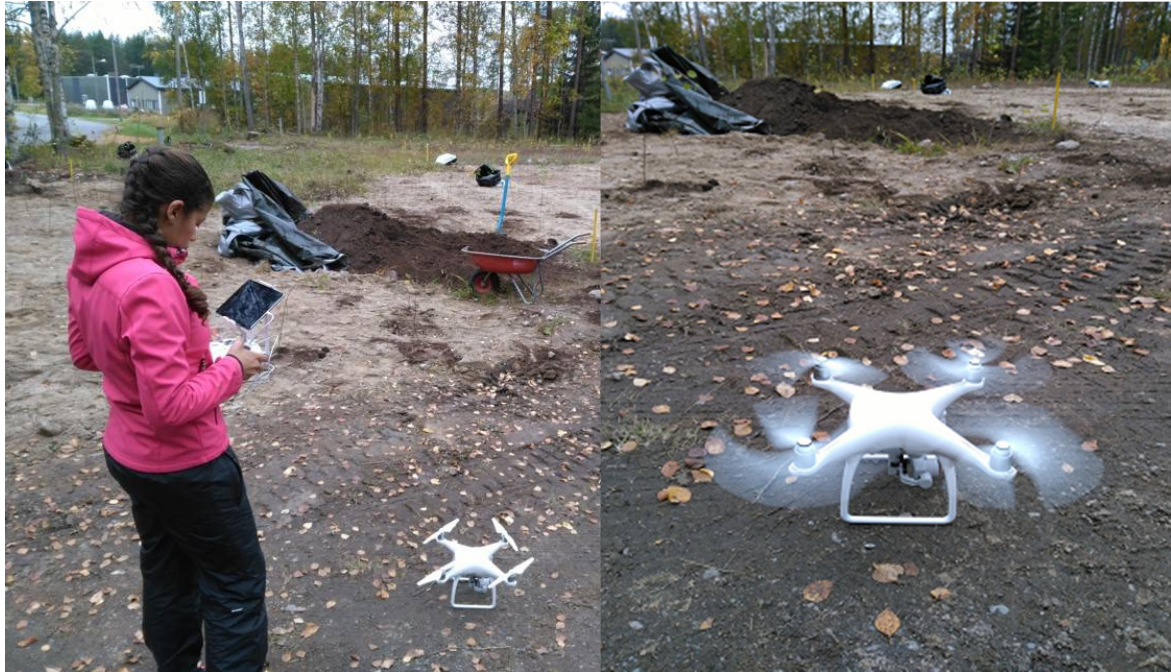
Fig 6.6. DJI Phantom 4 RPAS equipped with iPad for remote control using specially designed computer program for photographing a preselected area with the mini aircraft

The Virrat pilot site was photographed using DJI Phantom 4 remotely piloted aircraft system (RPAS) in October 2017. The pictures will be used for making GIS maps of the phytoremediation.
